Manhole Inspection Summary

Manhole # S09AA2021MH

Location Address: **2629 GLEN AVE**

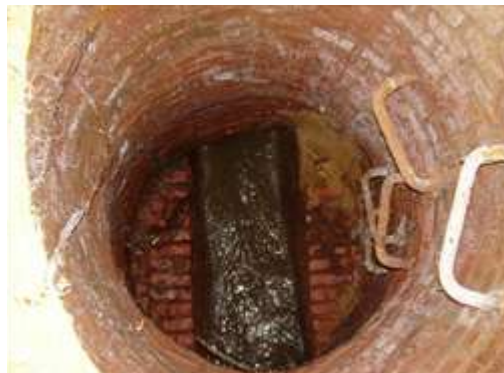
Top View

Corroded steps. Evidence of surcharge - Bench debris.

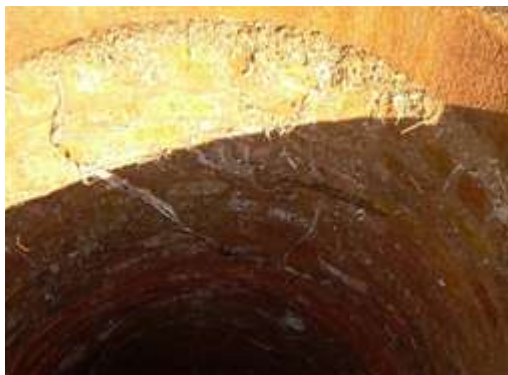
Defect

Condition: ☐ Sound ☐ Cracked ☒ **Root Intrusion** ☐ Loose Brick ☐ Deteriorated

Infiltration: ☐ None ☒ **Joint** ☐ Cracks ☒ **Mortar** ☒ **Roots** ☐ Wall

Adjustment root intrusion and infiltration.

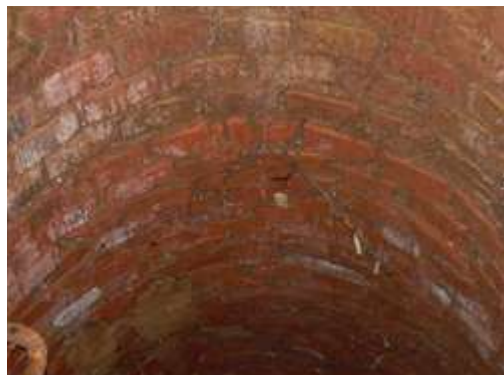
Defect

Condition: ☐ Sound ☐ Cracked ☒ **Root Intrusion** ☐ Loose Brick ☐ Deteriorated

Infiltration: ☐ None ☐ Joint ☐ Cracks ☒ **Mortar** ☒ **Roots** ☒ **Wall**

Corbel root intrusion and infiltration.

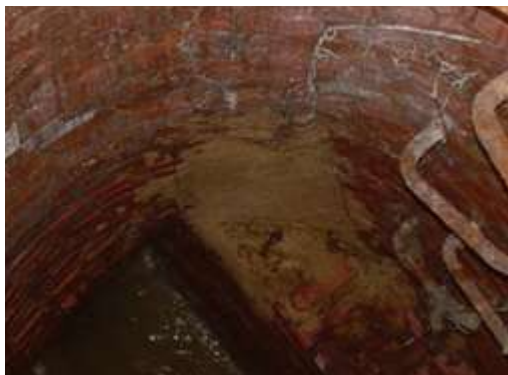
Defect

Condition: ☐ Sound ☐ Cracked ☒ **Root Intrusion** ☐ Loose Brick ☐ Deteriorated

Infiltration: ☐ None ☐ Joint ☐ Cracks ☒ **Mortar** ☒ **Roots** ☒ **Wall**

Barrel root intrusion and infiltration.

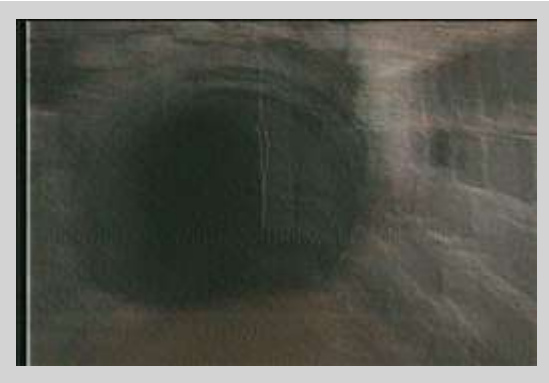
24 in. Circular Gravity Sewer Pipe Out @ 12 O'Clock

Infiltration: **Evidence** Pipe Seal Cond: **Roots**

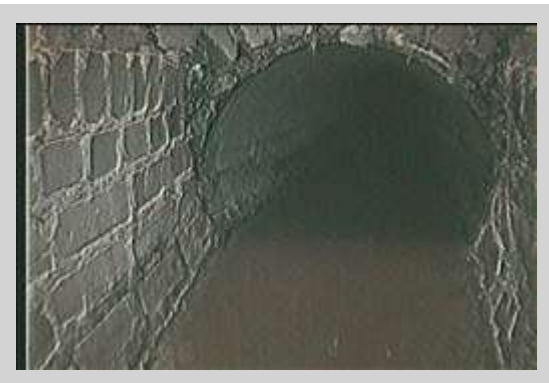
24 in. Circular Gravity Sewer Pipe In @ 6 O'Clock

Infiltration: **Evidence** Pipe Seal Cond: **Unknown**
